PROPOSED
EVERGATE SERVICE DISTRICT
MULTNOMAH COUNTY, OREGON

ENGINEER'S REPORT

SANITARY SEWER SYSTEM

AUGUST 1967

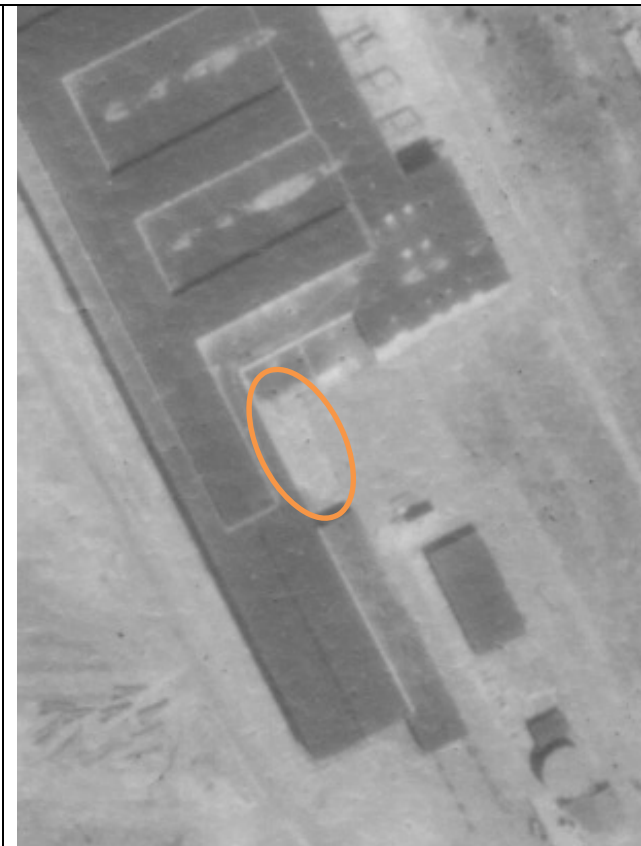
Portion of 1961 aerial photograph showing that the electrical equipment at substation 1 has been removed and the building does not appear to be in use.

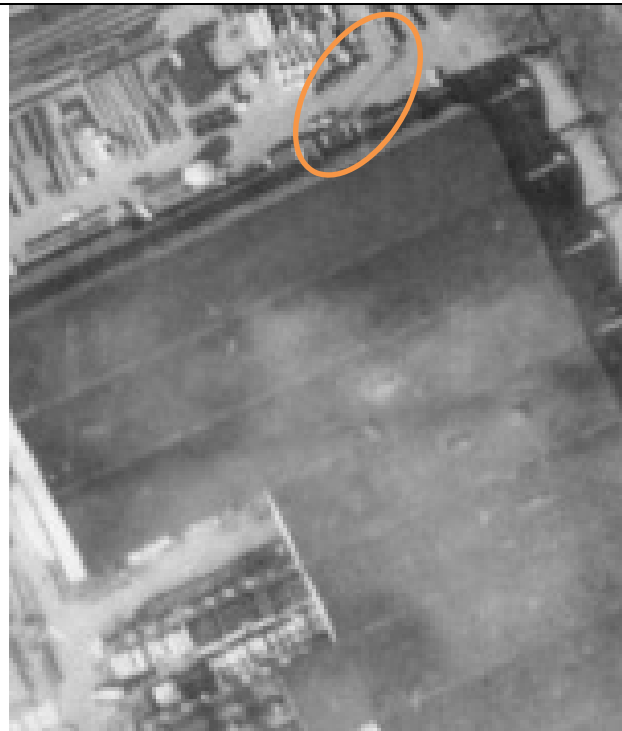
A portion of the 1956 West aerial photo showing a close-up view of the north end of the Assembly Building. The electrical equipment site can be distinguished by the shadow of the overhead pole in that location.

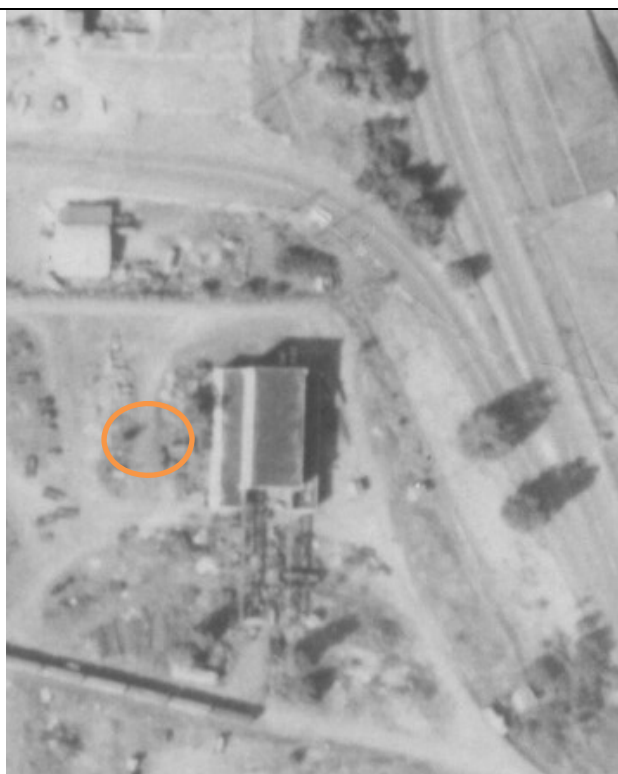
Shadow of what could be equipment in the Substation 5 location is visible in this 1964 aerial photo.

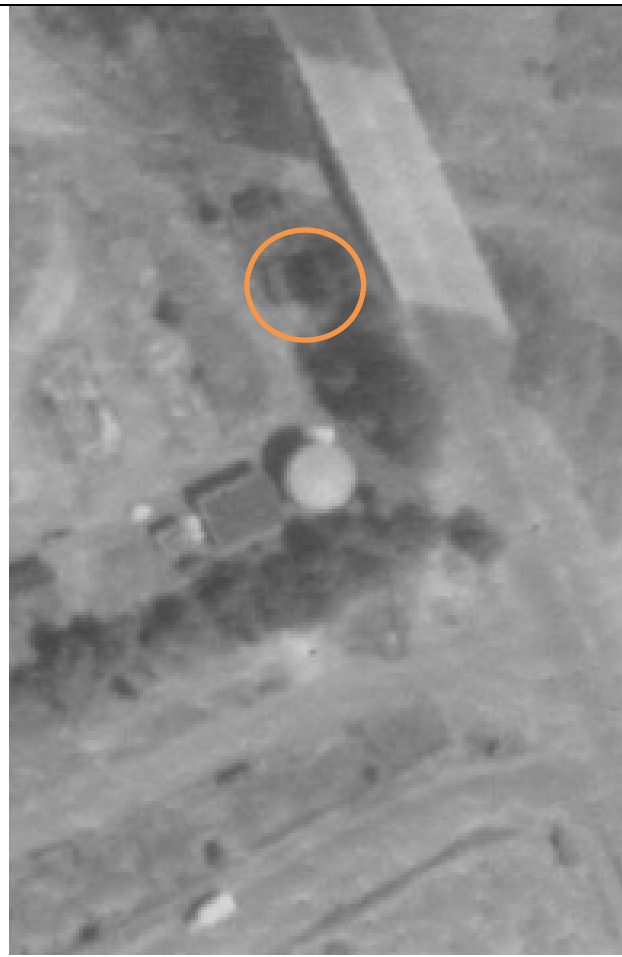
Portion of 1963 aerial – no photo shows the equipment location distinctly, but it is possible that this photo shows a platform or small shed in this location.

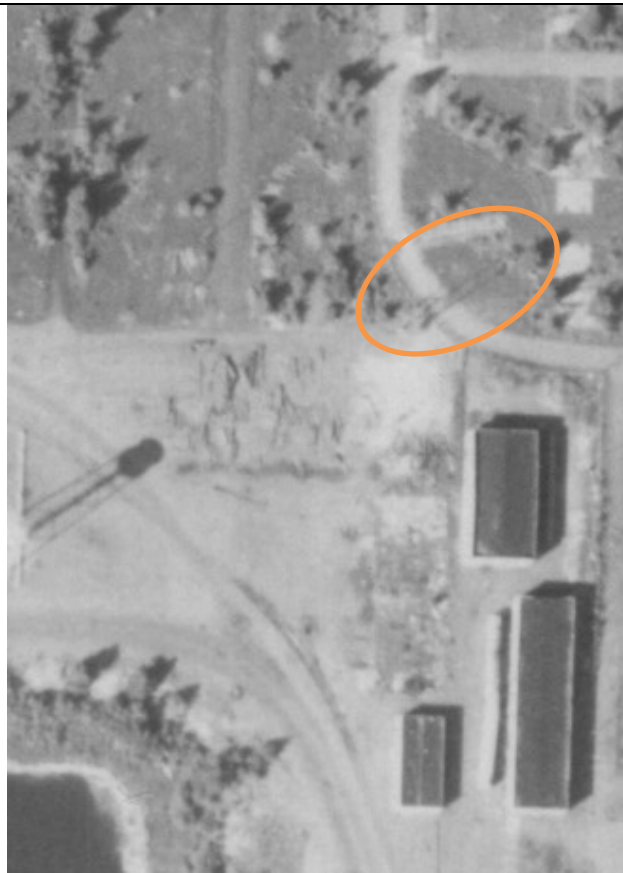
Switching Station 2

The 1964 aerial photo shows the shadow of some type of equipment in the location mapped as switching station 2.

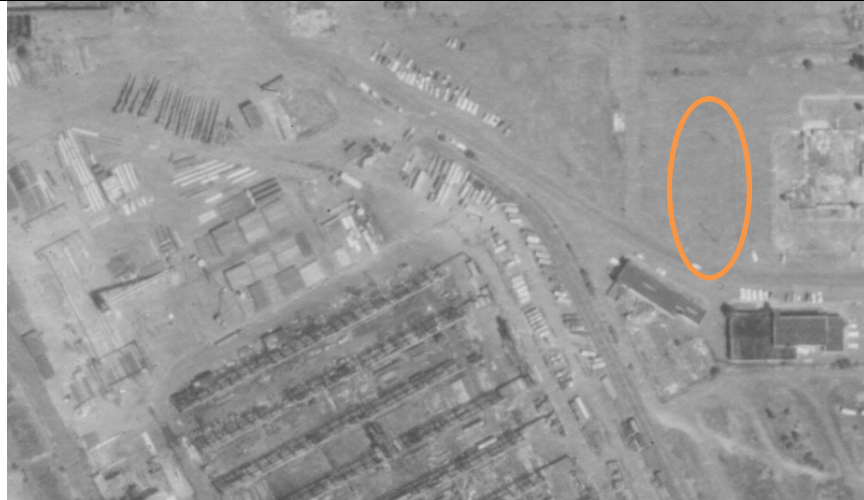
By 1961 the ordnance shed is gone and the poles are no longer visible along the mapped route, although other transmission line shadows can be seen, for example in the parking area at the upper right of this photo.

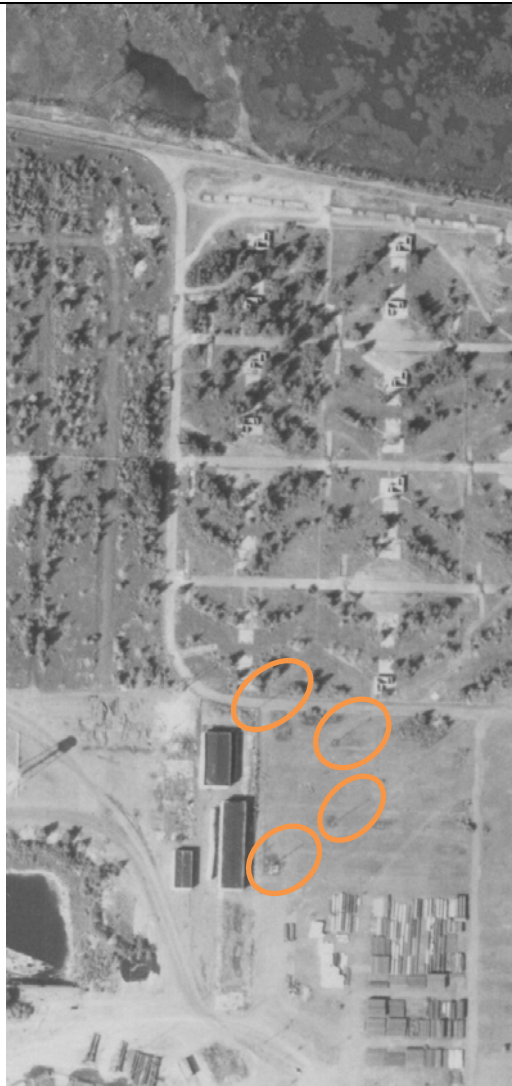
In 1964 you can see shadows of overhead poles and an equipment platform in substation 4's location (not part of PGE transaction).

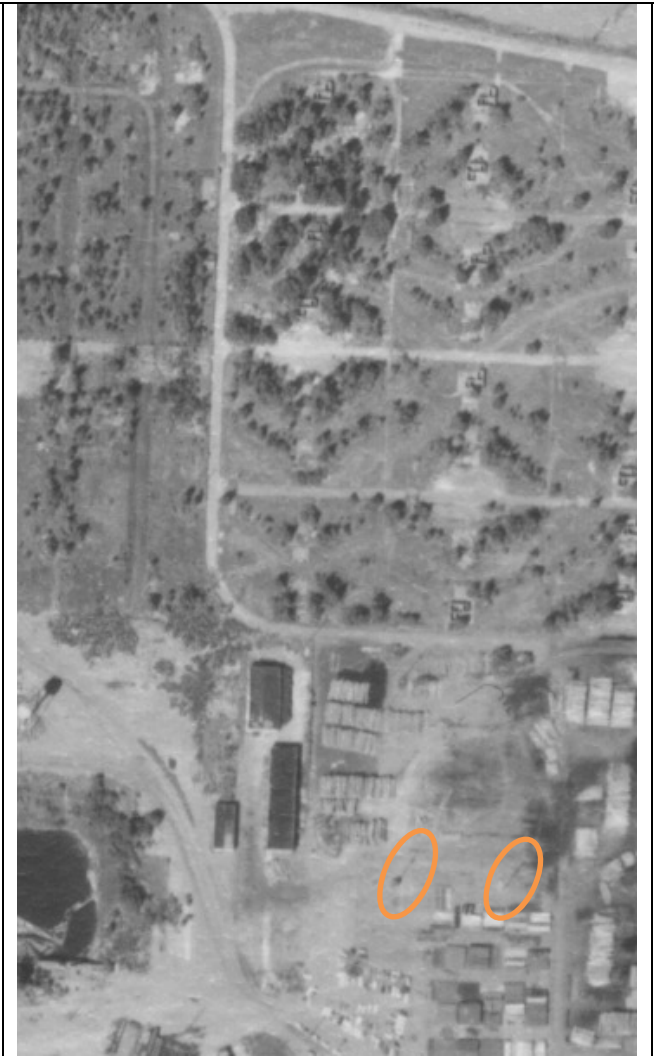
By 1968, the equipment platform site is gone and the locations of overhead distribution poles have changed.

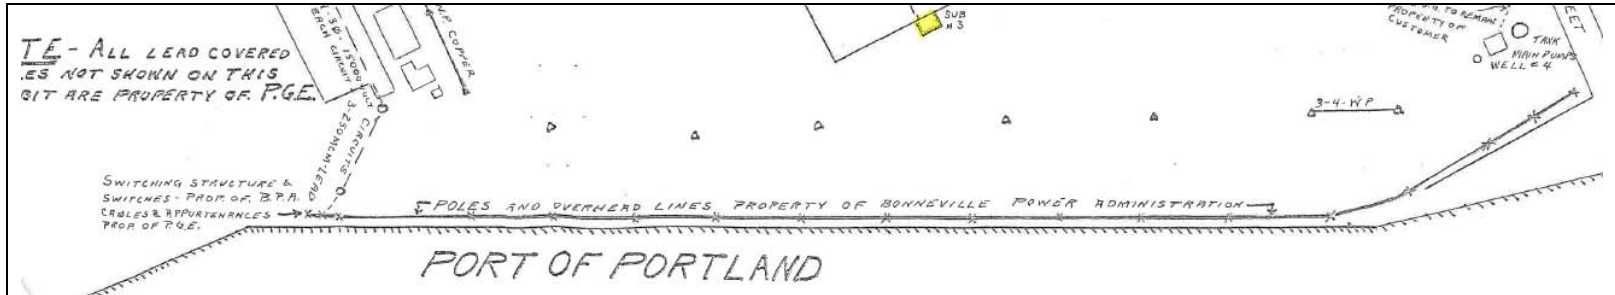
Rights to Dulien Interest in BPA Power line

<p>The 1952 documents do not include a map showing the BPA overhead line, but I presume it to be the one along the southern parcel boundary.</p>

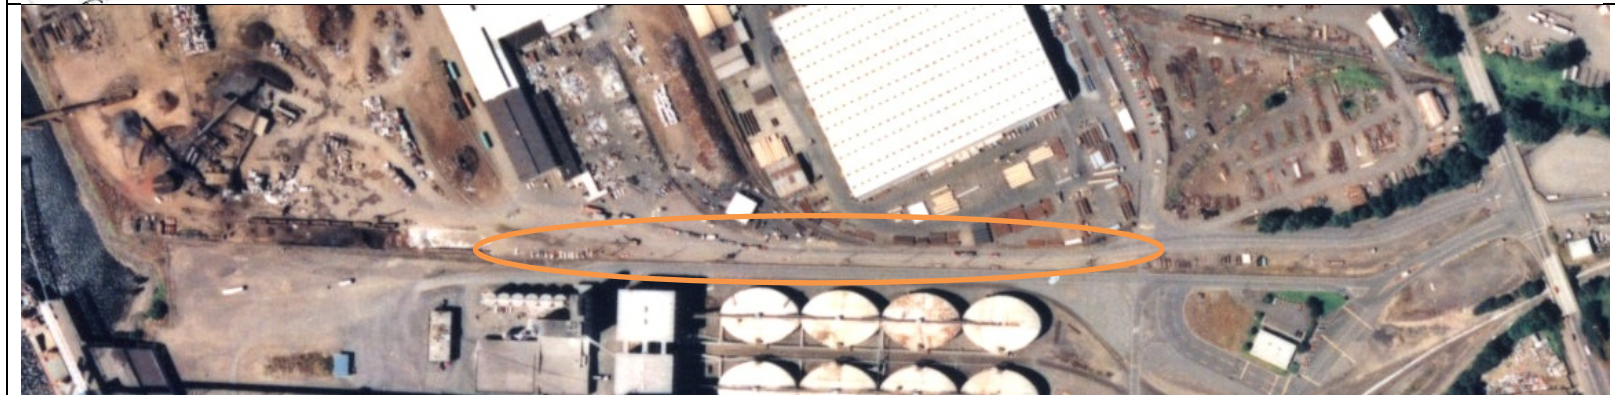
<p>Shadows of overhead distribution system poles are clearly visible along the BPA alignment in all of the aerial photographs. This one is from 1994.</p>

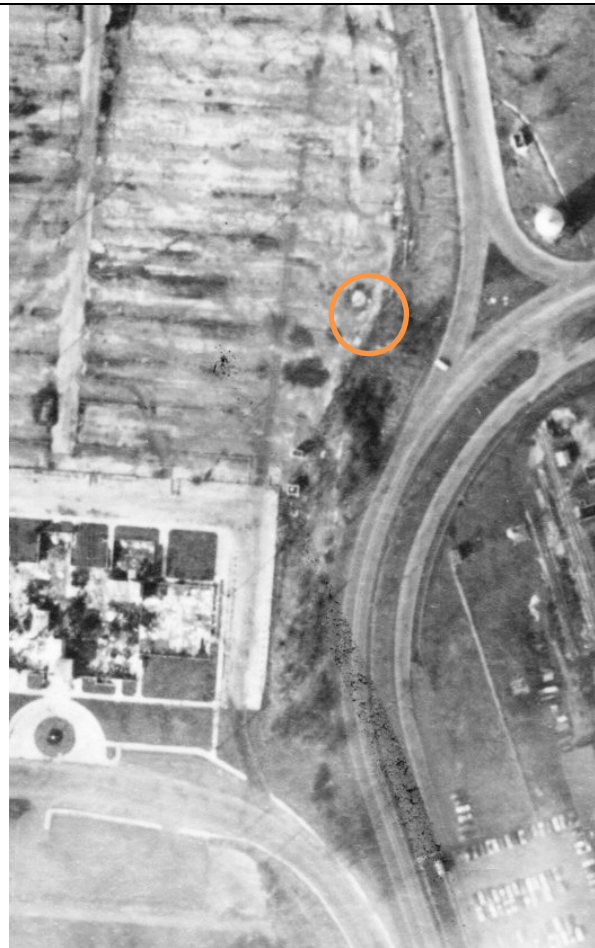
1956 aerial photograph showing possible equipment platform in mapped location of Parcel E Switching Station.

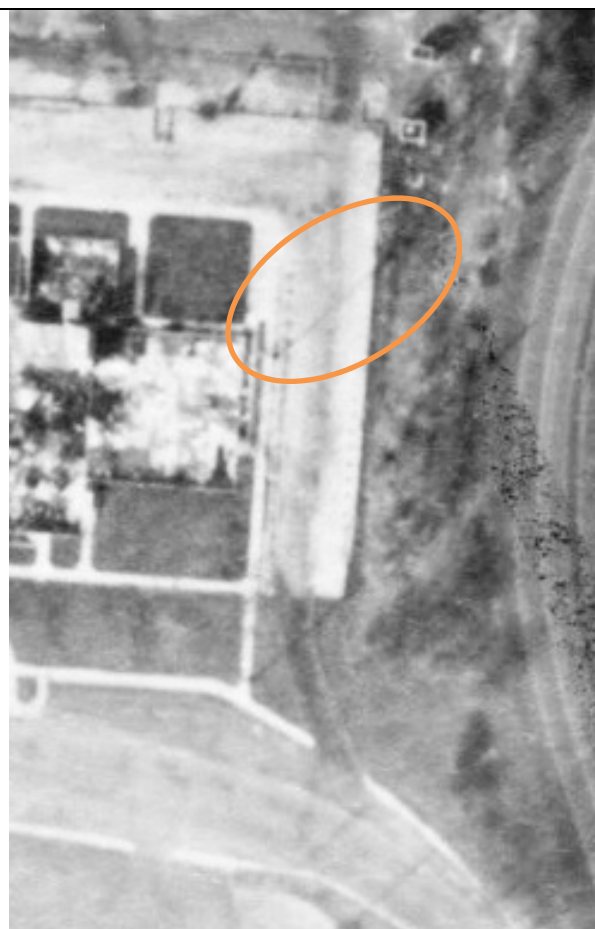
The 1956 aerial photo shows the shadows of the pole in the mapped location of the pole-mounted transformers.

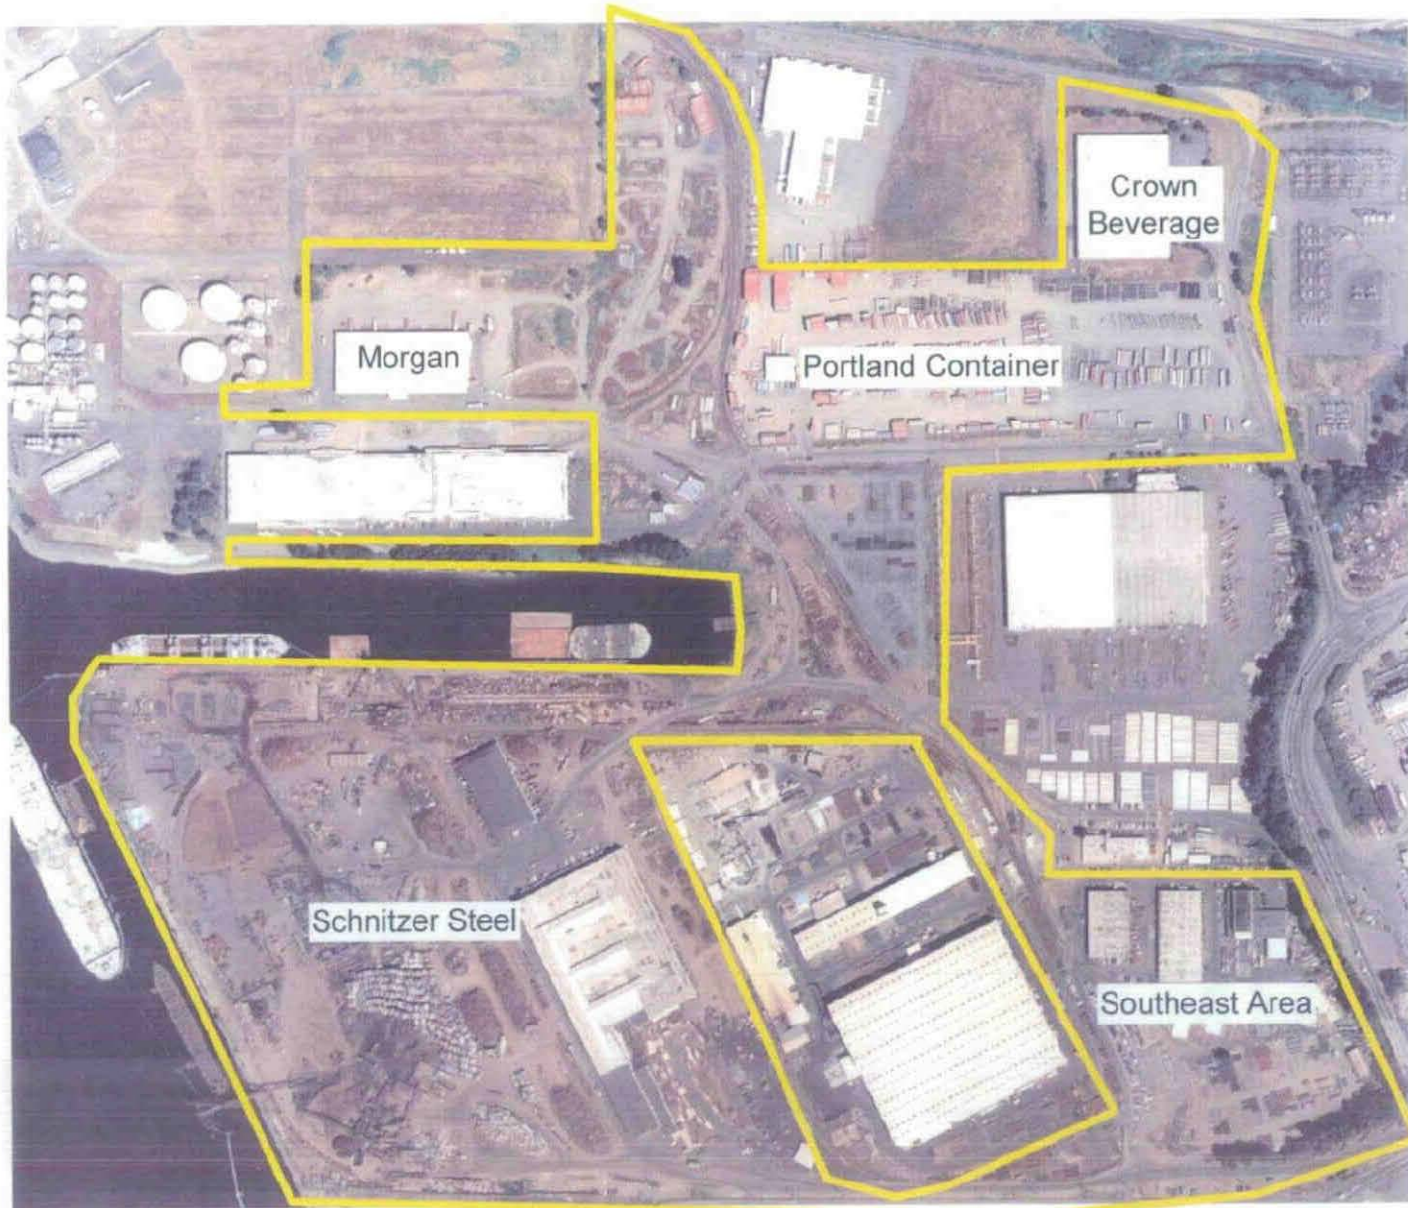
Figure 2-10
Areas of Site During SIC Ownership
Burgard Industrial Park

Approximate Scale
550 Feet

For the purposes of this report, the historical features and activities on these different portions of the Site during SIC's ownership are described separately. Soil and groundwater sampling and analysis that have been performed on the parcels are also discussed in each section. Figure 2-10 shows the location of these different portions of the Site.
